2003 Operations, Maintenance, and Monitoring Report

GIWW (GULF INTRACOASTAL WATERWAY) to CLOVELLY HYDROLOGIC RESTORATION

State Project Number BA-02 Priority Project List 1

July 8, 2004 Lafourche Parish

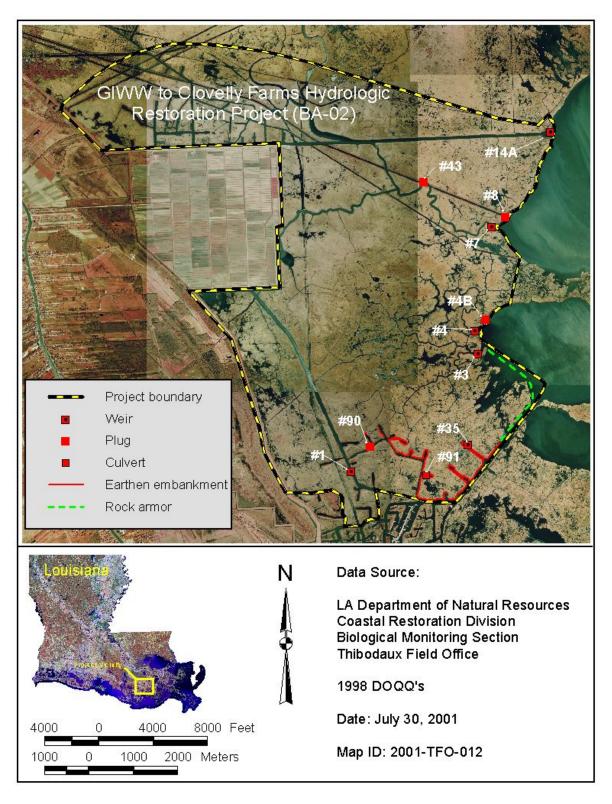
Figure 2. Project infrastructure map for the GIWW (Gulf Intracoastal Waterway) to Clovelly (BA-02) Hydrologic Restoration project.

- Construction of one 1,665 linear ft (507.5 m) fixed crest rock riprap weir with an 80 ft (24.4 m) barge bay, with a crest elevation of 4.0 ft NAVD88 and the invert of the boat bay at an elevation of -6.5 ft NAVD88 (figure 2; site 14A).

- Construction of one 511 linear ft (155.8 m) rock riprap channel plug with a crest elevation of 3.5 ft NAVD88 (figure 2; site 4B).
- Construction of one 213 linear ft (64.9 m) rock riprap channel plug with a crest elevation set at 4.0 ft NAVD 88 (figure 2; site 90).

NAVD88 using a rotatable crane with a hand winch. The fixed crest section of the structure was constructed with earthen wingwalls to a crest elevation of 2.89 ft NAVD88 on either side of the weir (figure 2; site 35).

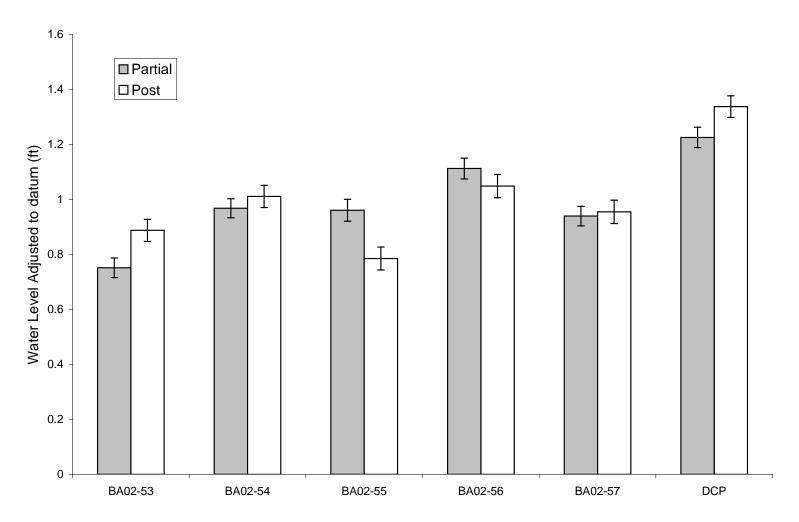
Initial observations displayed little change of water levels between partial and post-construction among project stations and the Little Lake DCP (figure 17). Water levels tended to be greater in the more northwestern project stations suggesting an overall movement of water from a northwest to southeast direction towards Little Lake. Personal observations during field trips support the idea of net water movement towards Little Lake. GLM analysis revealed no significant differences between partial and post-construction periods for any of the stations or the Little Lake DCP (table 2). The Little Lake DCP does not use the same vertical datum and thus any comparisons with project stations other than partial versus post-construction would be invalid. When BA02-58 is used in the analysis, BA02-55 had a significant decrease while none of the other stations had a significant decrease (table 3). However, these results may be misleading as longer datasets revealed no significant differences suggesting that water levels were higher overall in the latter part of 2002 and all of 2003.

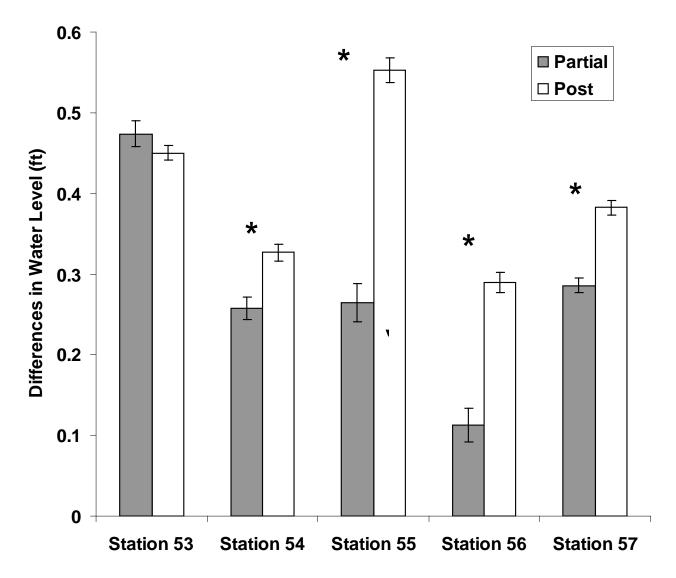
Figure 18. Differences in water levels between the Little Lake DCP and five of the project continuous recorders partial vs post-contruction for the GIWW to Clovelly Hydrologic Restoration (BA-02) project. Note: * indicates significance value where P<0.05.

BACI analyses showed that there may be an effect between partial and post-construction in water level. The mean water level at the Little Lake DCP and at BA02-53 increased about the same amount between partial and post construction and thus the mean differences showed no statistically significant changes (figure 18). Conversely, differences in water level were significant between partial and post-construction among BA02-54, BA02-55, BA02-56, and BA02-57. Average water level at these stations either slightly decreased or increased when compared to the large increase at Little Lake DCP. Therefore the project was essentially maintaining a more consistent water level relative to what we saw in Little Lake except at BA02-53.

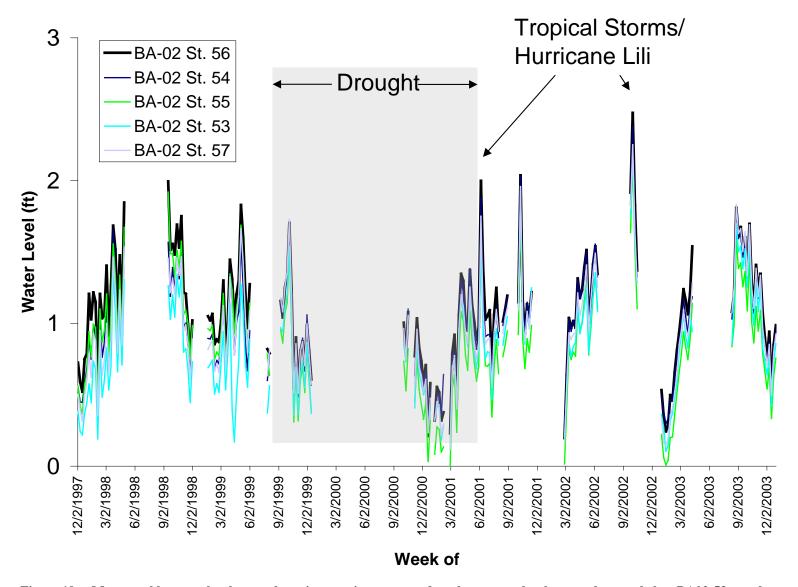
Figure 19. Mean weekly water levels at each project continuous recorder where water levels were above or below BA02-53 marsh elevation for the GIWW to Clovelly Hydrologic Restoration (BA-02) project.

When water levels were compared partial and post-construction for values where water level was either above or below BA02-53 marsh elevation, only BA02-55 showed a significant decrease in water level in both cases (figure 19). This result is intriguing as BA02-55 does not have a significant decrease when all the data are used. BA02-55 was mid-range for water level during partial construction but had the lowest average water level of each of the project stations post-construction. Moreover, upon completion of construction the water level at BA02-55 became the lowest in relation to all other stations as they varied together.

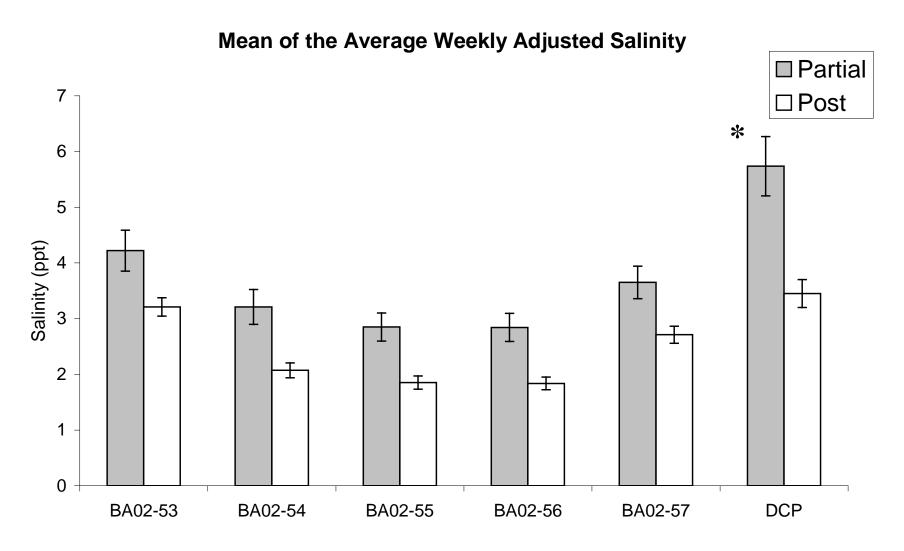
Figure 20. Mean weekly averages of the adjusted Salinity (ppt) at five project continuous recorder stations and the Little Lake DCP station both partial and post-construction for the GIWW to Clovelly Hydrologic Restoration (BA-02) project. Note: * indicates significance value of P<0.05.

The Little Lake DCP showed a significant decrease in salinity while each of the project stations decreased but were not significant (figure 20; table 5). Stations located in the southeastern portion of the project, or closer to Little Lake, tended to have overall greater salinity. When BA02-58 is used in the analysis, there are no significant differences between partial and post-construction data (table 6).

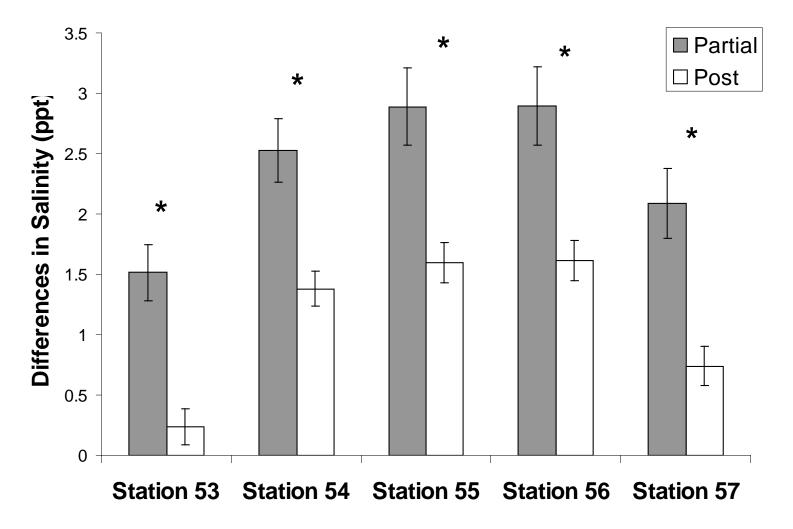
Figure 21. Differences in salinities between the Little Lake DCP and five project continuous recorders partial vs. post-construction for the GIWW to Clovelly Hydrologic Restoration (BA-02) project. Note: * indicates a significance value of P<0.05.

Results for salinity from BACI analysis are similar to those found for water level where salinity differences decrease significantly for each project station during post-construction (figure 21). That is, salinity in Little Lake decreased significantly while project stations did not. Usually Little Lake was more saline than each of project stations. However, there was a period of time late in 2003 where many of the project stations had higher salinity than the Little Lake DCP (Appendix A). This occurrence may be due to Mississippi River water diverted into Davis Pond during August 2003. Unfortunately we are unable to confirm if this event caused a decline in the salinity in Little Lake during this observed time period.

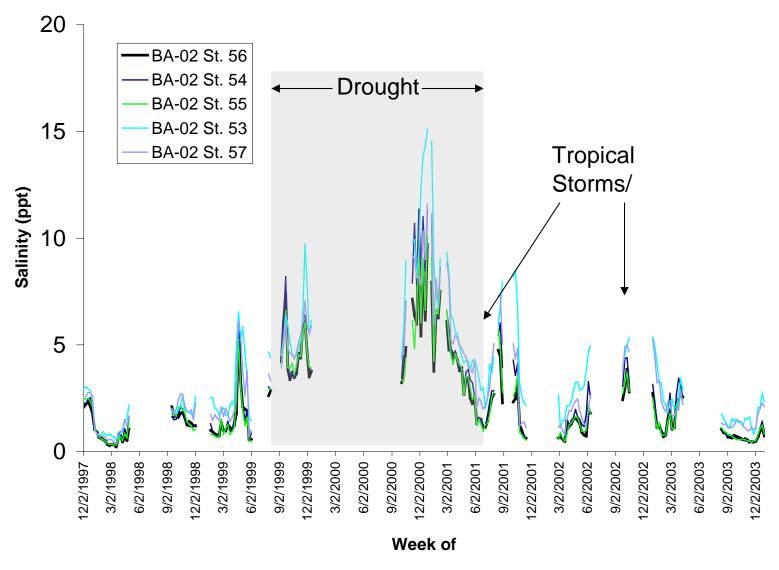
Figure 22. Average weekly salinities at each project continuous recorder where water levels were above or below BA02-53 marsh elevation for the (BA-02) GIWW to Clovelly Hydrologic Restoration project.

When salinities were compared partial and post-construction for values where water level was either above or below BA02-53 marsh elevation, no significant differences are apparent in salinity for either case (figure 22).

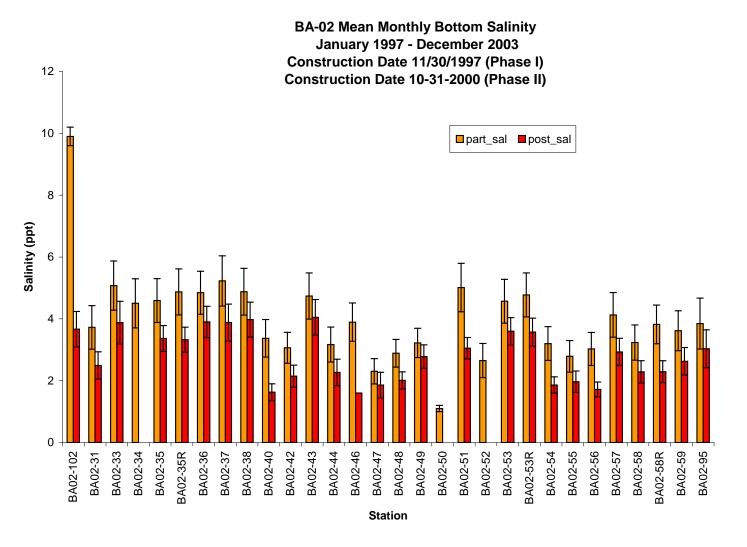
Figure 23. Mean Monthly Discrete Bottom Salinity partial vs. post-construction for the GIWW (Gulf Intracoastal Waterway) to Clovelly Hydrologic Restoration (BA-02) project

Mean discrete bottom salinities appear to have dropped at all of the stations throughout the project area from partial to post-construction (figure 23).

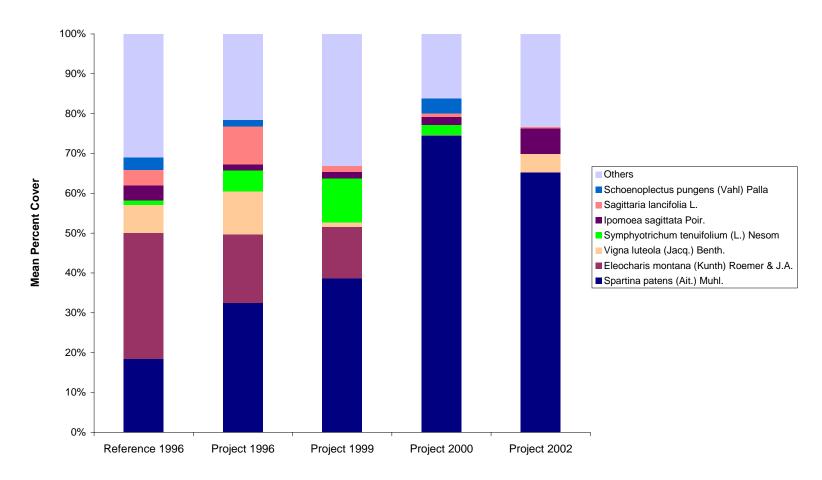
Figure 24. Mean percent cover of selected species at the GIWW to Clovelly Hydrologic Restoration (BA-02) preject and reference areas.

Vegetation data were not collected during 2003 for this project, however data collected in previous years indicate that the percent cover of *Spartina patens* (Ait.) Muhl. (marshhay cordgrass) a brackish marsh species, has been increasing within the project area. The increase in cover suggests a net overall change of the dominate marsh vegetation from intermediate to more saline marsh species (figure 24).

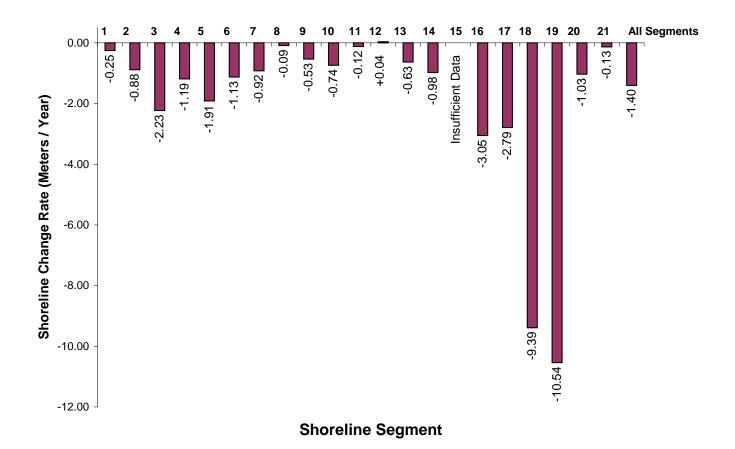
Figure 28. Shoreline Change rate in meters per year for each segment of shoreline where data was collected for the GIWW (Gulf Intracoastal Waterway) to Clovelly Hydrologic Restoration (BA-02) project.

The average shoreline change rate for the project shoreline between November 2000 (as-built) and March 2003 (post-construction) was -1.40 m yr⁻¹ (-4.56 ft yr⁻¹) (figure 28). Shoreline losses were greatest along segments 3, and 5, and 16 through 19. The change rates along segments 16, 18, and 19 were equal to or greater than the historical rate of -3.05 m yr⁻¹ (10 ft yr⁻¹). Additionally, inspections conducted on the project's rock rim shoreline protection structure indicated that the riprap dike has settled along two sections (figures 29-30). The areas of settlement included stations 7+00 through 13+00 and stations 36+00 through 41+00. These two areas bear closer scrutiny since settlement may have left the shoreline more vulnerable to wave energy which could explain the greater shoreline losses behind these stations.

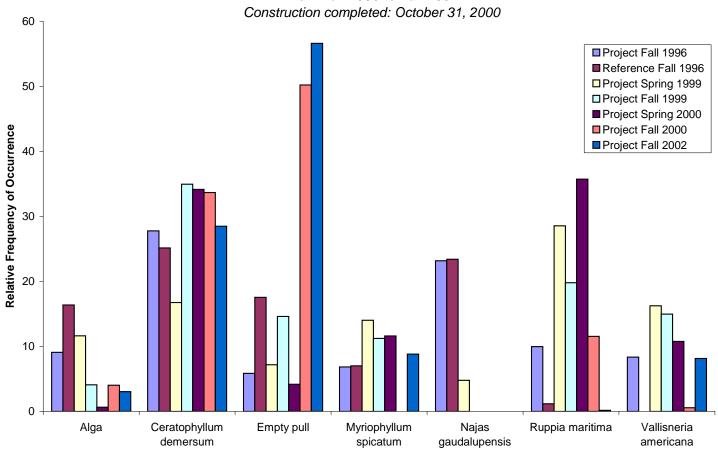
Figure 31. Relative frequency of occurrence of selected Submerged Aquatic Vegetation species for the GIWW to Clovelly Hydrologic Restoration (BA-02) project.

SAV data was not collected in 2003, however data from previous years indicates variability in relative abundance of SAV (figure 31). An increase in the frequency of occurrence of empty pulls (samples with no SAV) occurred immediately following the drought in 2000.
